**“COMPLETE STREETS”
MEANS SAFER ACCESS STREETS
FOR ALL USERS**

**TRAFFIC CALMING CASE STUDIES
VILLAGE OF GREAT NECK PLAZA, NY**

**VISION LI SMART GROWTH SUMMIT
NOVEMBER 18, 2011**

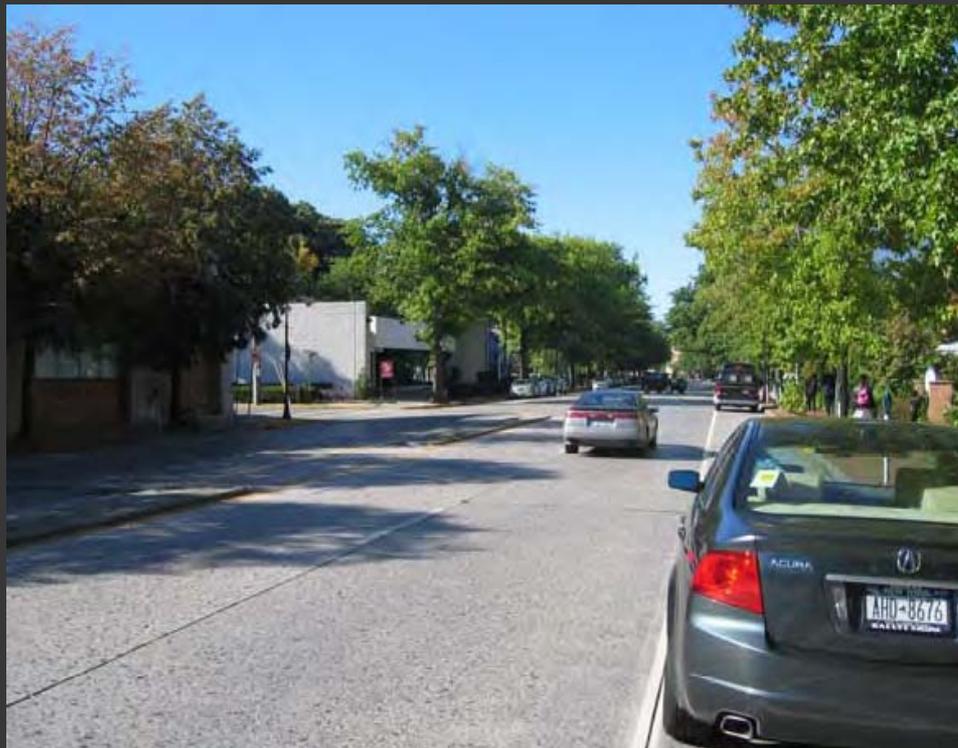
GREAT NECK RD. PHOTOS “BEFORE”

- Original 1920's concrete pavement with two (2) lanes in each direction made for a speedway, and unsafe conditions for pedestrians/bicyclists
- Pavement worn smooth and skid resistance was poor, high accident history of 65.5 crashes/yr.
- Numerous breaks in 4-ft. wide raised median rendered it ineffective

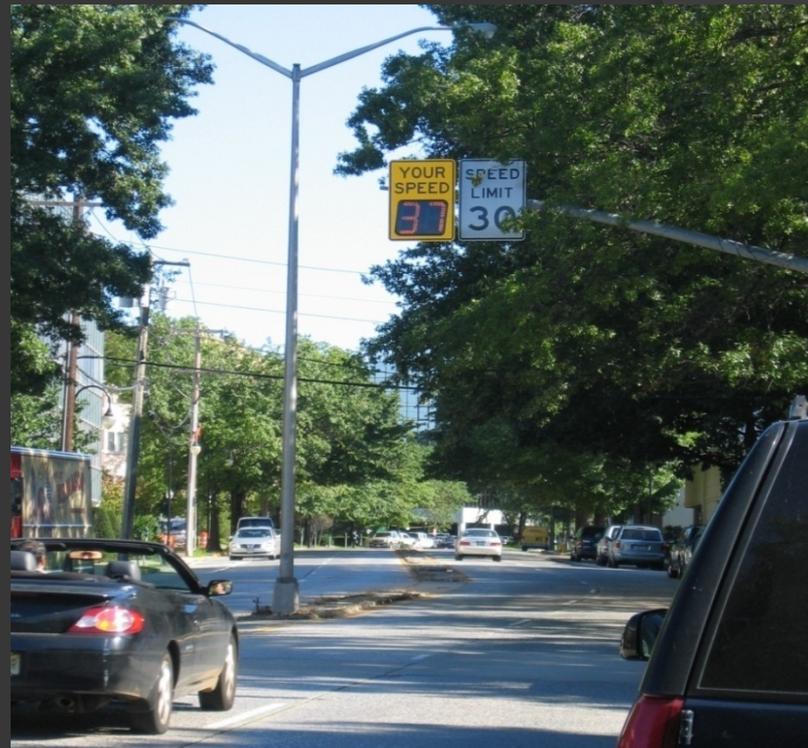
- Portions of 4-ft. median with overhead lighting, posed tremendous safety concern in vehicular accidents
- Note: vehicle speed at 37 mph in radar device; over 30 mph posted village speed limit

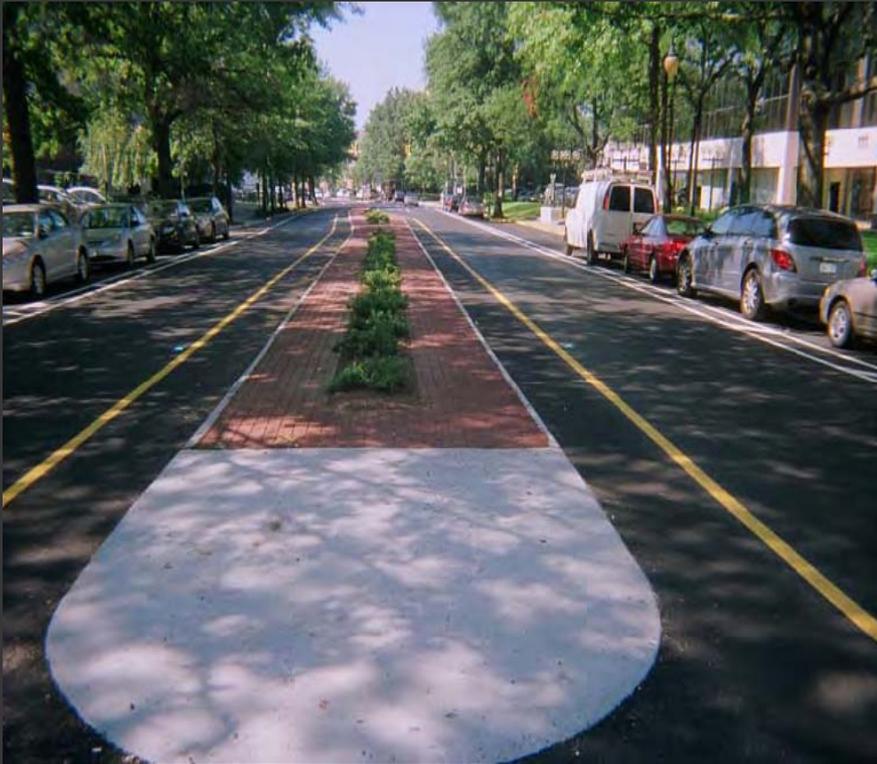
GREAT NECK ROAD “ROAD DIET” PHOTOS -“AFTER”

- One travel lane in each direction, 12' width (10' before) and 3' curb offset
- Re-constructed center median of 10' with 3' wide stamped asphalt pavement (Streetprint) mow strip areas along both sides
- 2 ft. safety strip along travel lane for parking and safe access for bicyclists

- One lane in each direction of travel was removed -"Road Diet"
- Left/U-turn lanes provided at intersections
- Roadway resurfaced with new asphalt to increase skid resistance
- Consistent, wider landscaped median was re-established
- Bulb-out sidewalks to reduce crossing distances for pedestrians
- High-visibility crosswalk markings and warning signs
- Pedestrian refuges in median to minimize exposure of pedestrians to traffic
- Safety zone between travel lane and parked vehicles to improve safety for drivers entering/exiting their vehicles, and for bicyclists

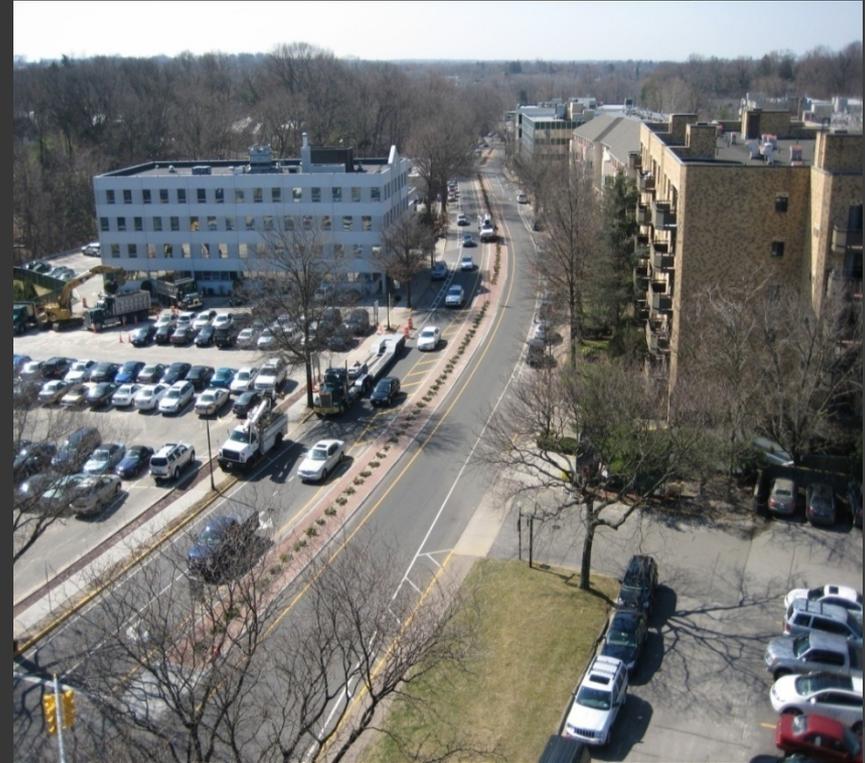
- Aerial view from rooftop of commercial office bldg. at 111 Great Neck
- Vehicles traveling in a single lane, 30 mph speed limit is achieved and now better obeyed (feeling that traffic is truly “calmed” and much slower, safer for all modes)

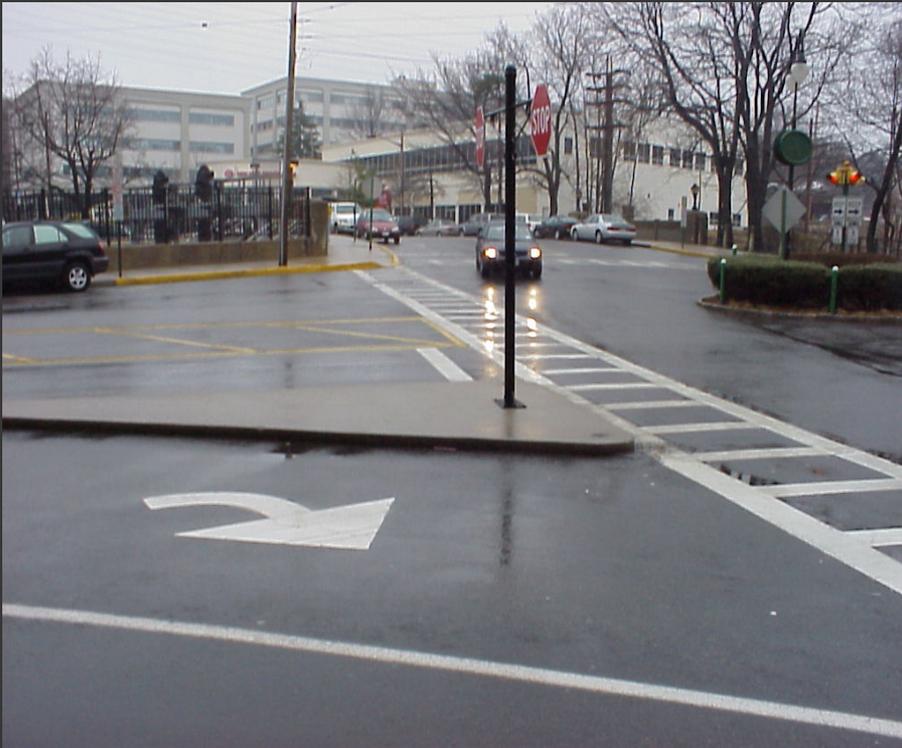
ROUNDBABOUT PHOTOS “BEFORE”

Raised concrete island for channelization, more visible stop signs, and right turn separator (Problem: Long, 120-ft. crossing, limited pedestrian refuge & limited ped. separation from vehicles).

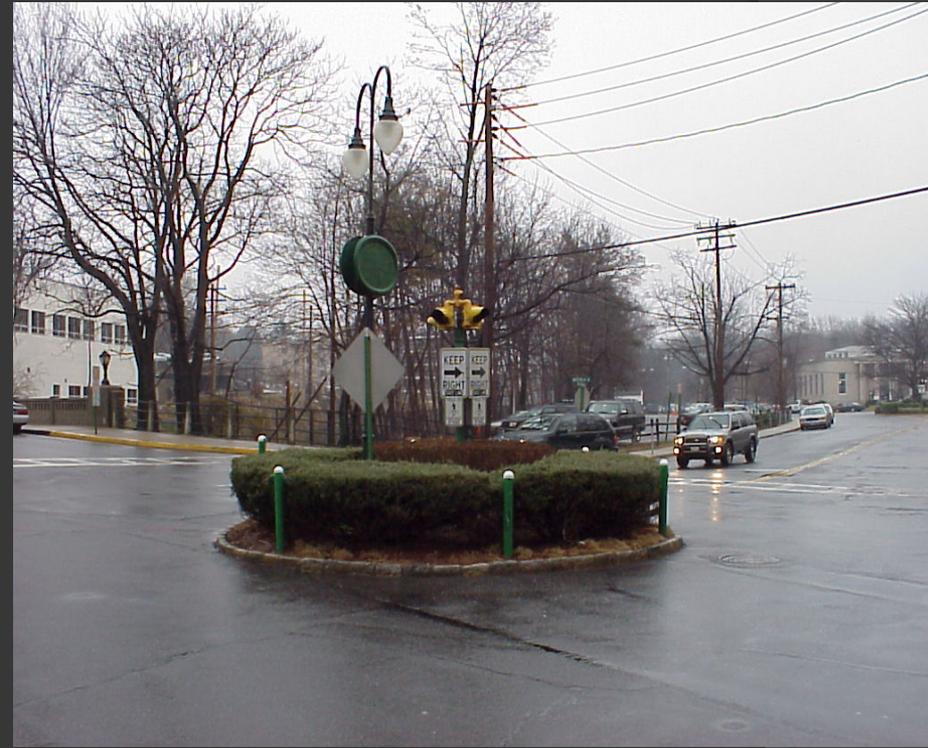
- **Tiny** traffic circle, four-way stops at intersection caused great motorist confusion (who gets to go?).
- **“Rolling”** stops + thru traffic speeds = not seeing pedestrians caused accidents and near accidents
- **Reduced** visibility in traffic circle

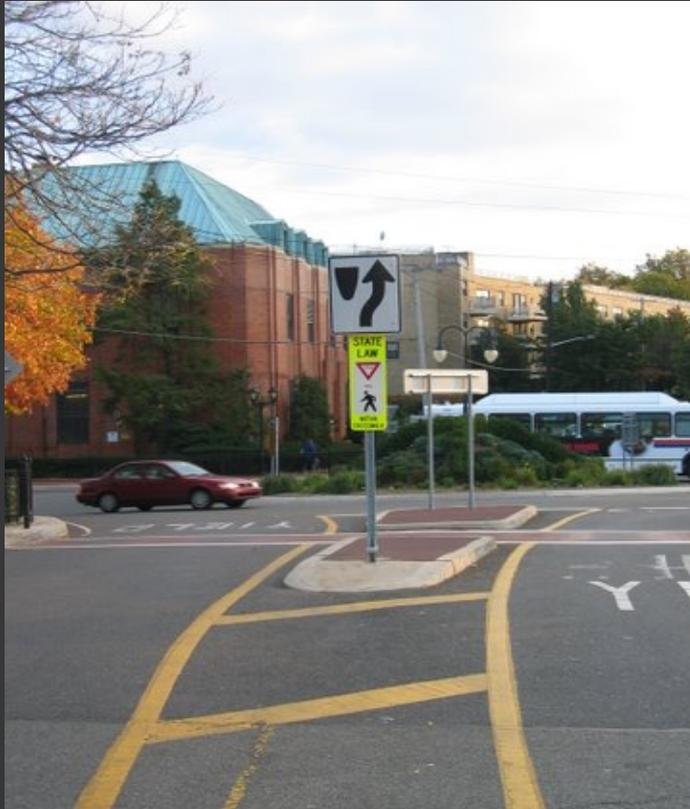
Added "Yield to Pedestrian in Crosswalk" signage at all 4 approaches to supplement pavement markings.

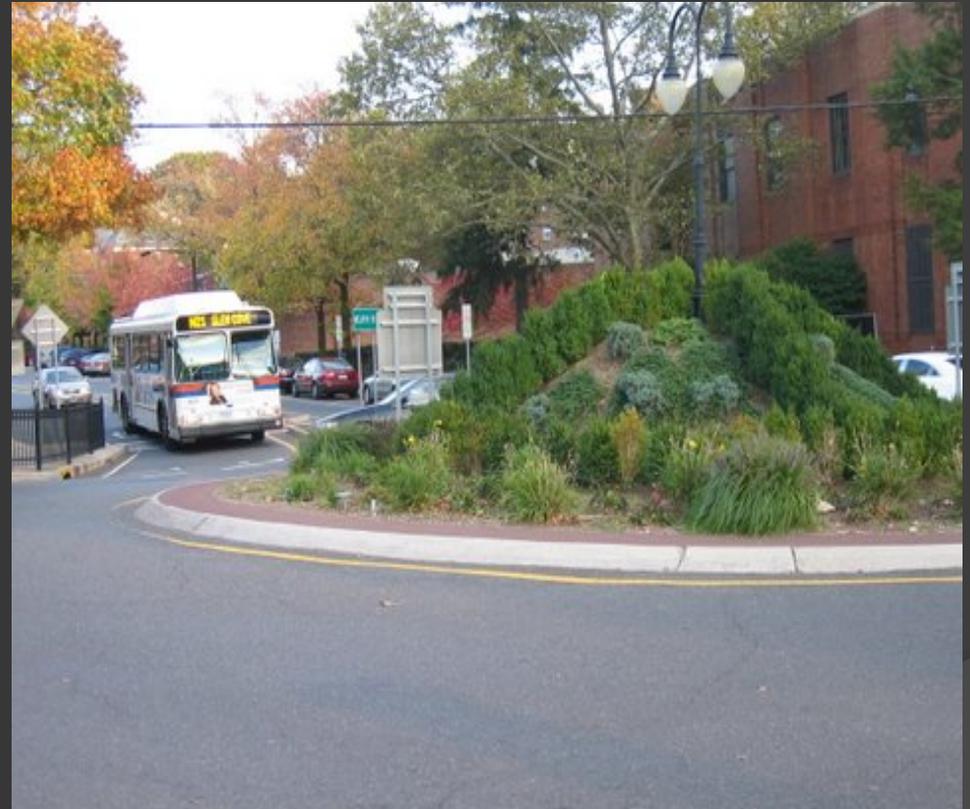
Center island mound showing plantings are maturing and filling in. In background, a MTA-LI Bus negotiates turn with protective railing for pedestrians visible.

- **Bulb-out sidewalks** installed to reduce crossing distances for pedestrians
- **Contrasting pavement** coloring (brick color) for crosswalk pavement
- **"YIELD" markings** for pedestrians in crosswalks
- **Pedestrian refuges** in "splitter" islands minimize exposure of pedestrians to traffic
- **Mountable curb** accommodates MTA-LI commuter buses and other large vehicles

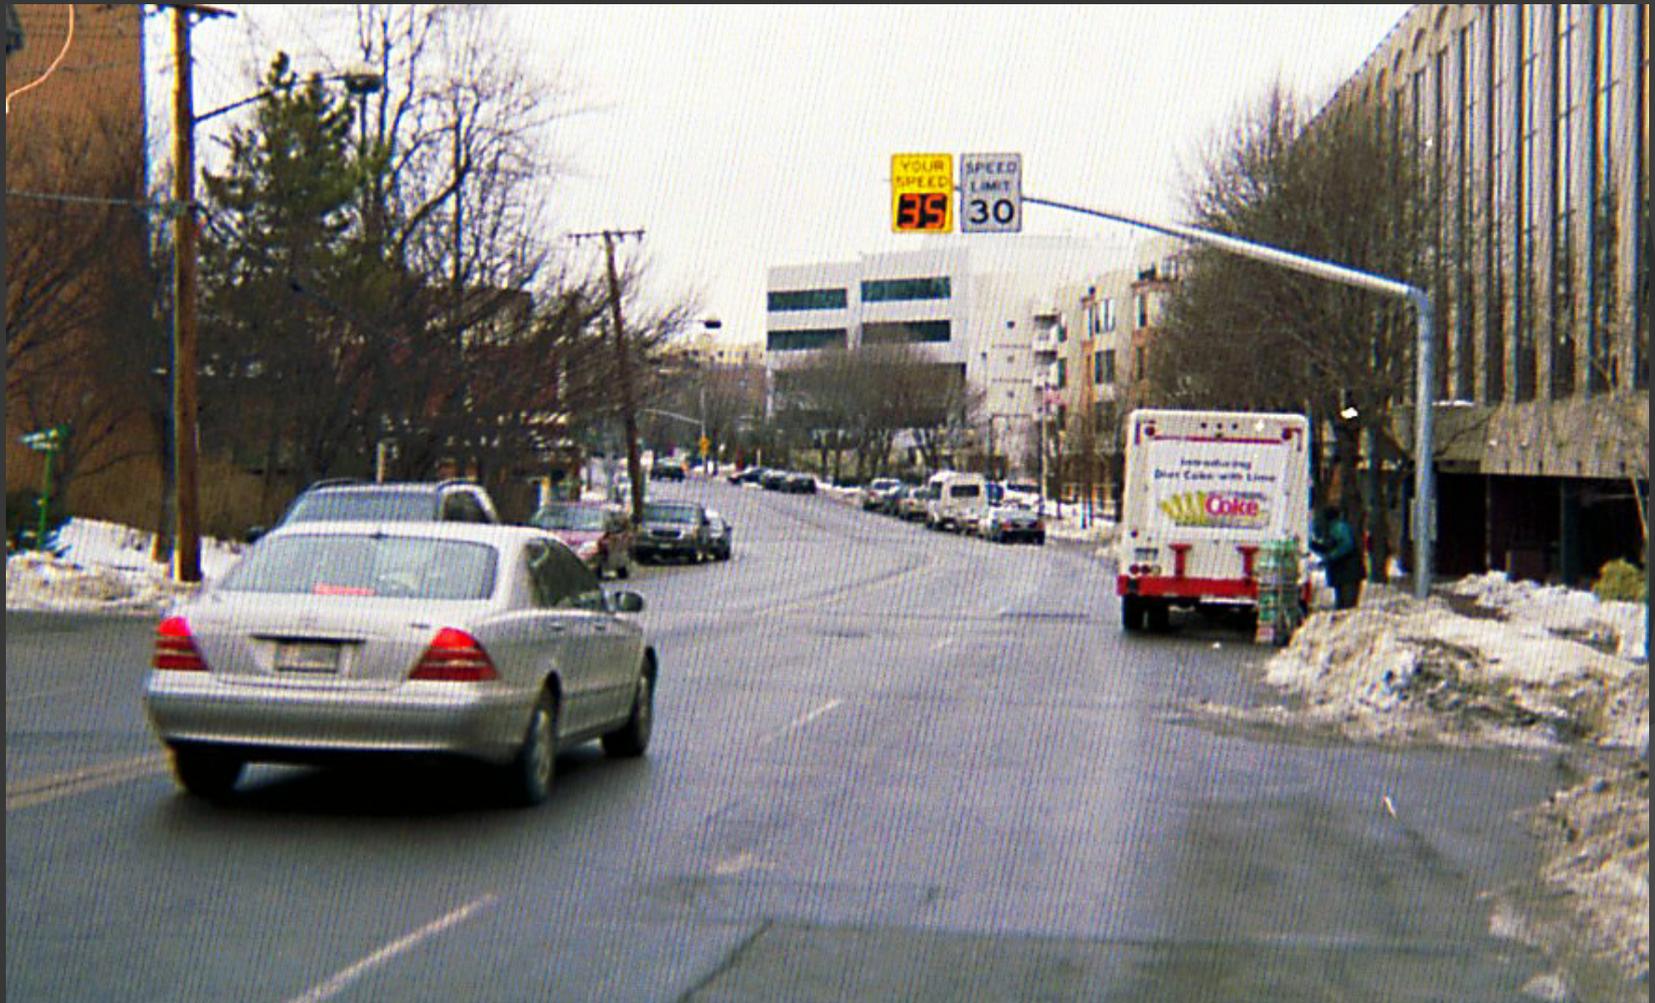
SPEED AWARENESS DEVICES

Permanent overhead devices with radar detection and digital readout for “Your Speed” versus posted Speed Limit

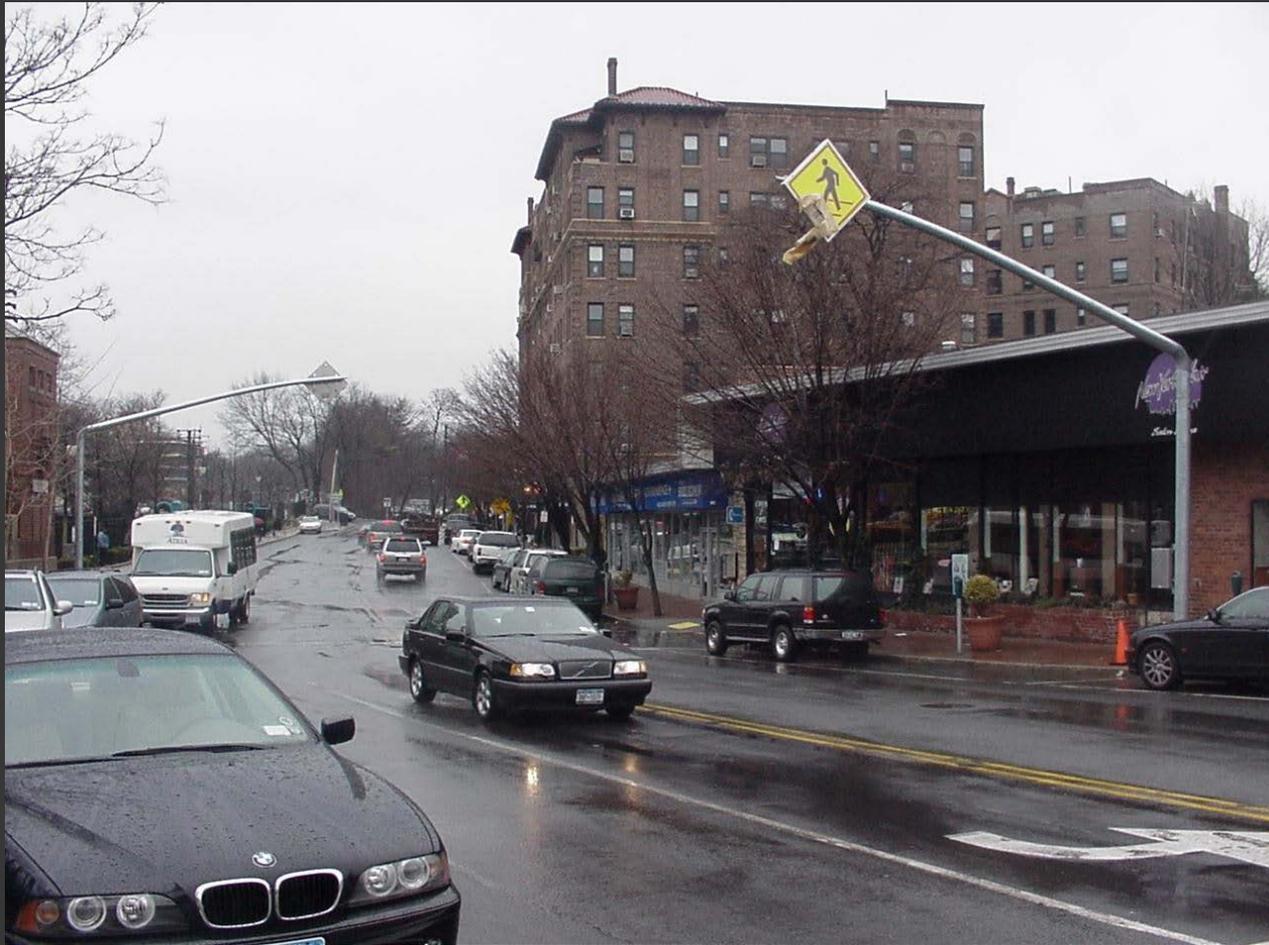
PEDESTRIAN SAFETY SYSTEMS

Illuminated overhead blinking ped. warning sign advising motorists of pedestrians crossing @ mid-block location

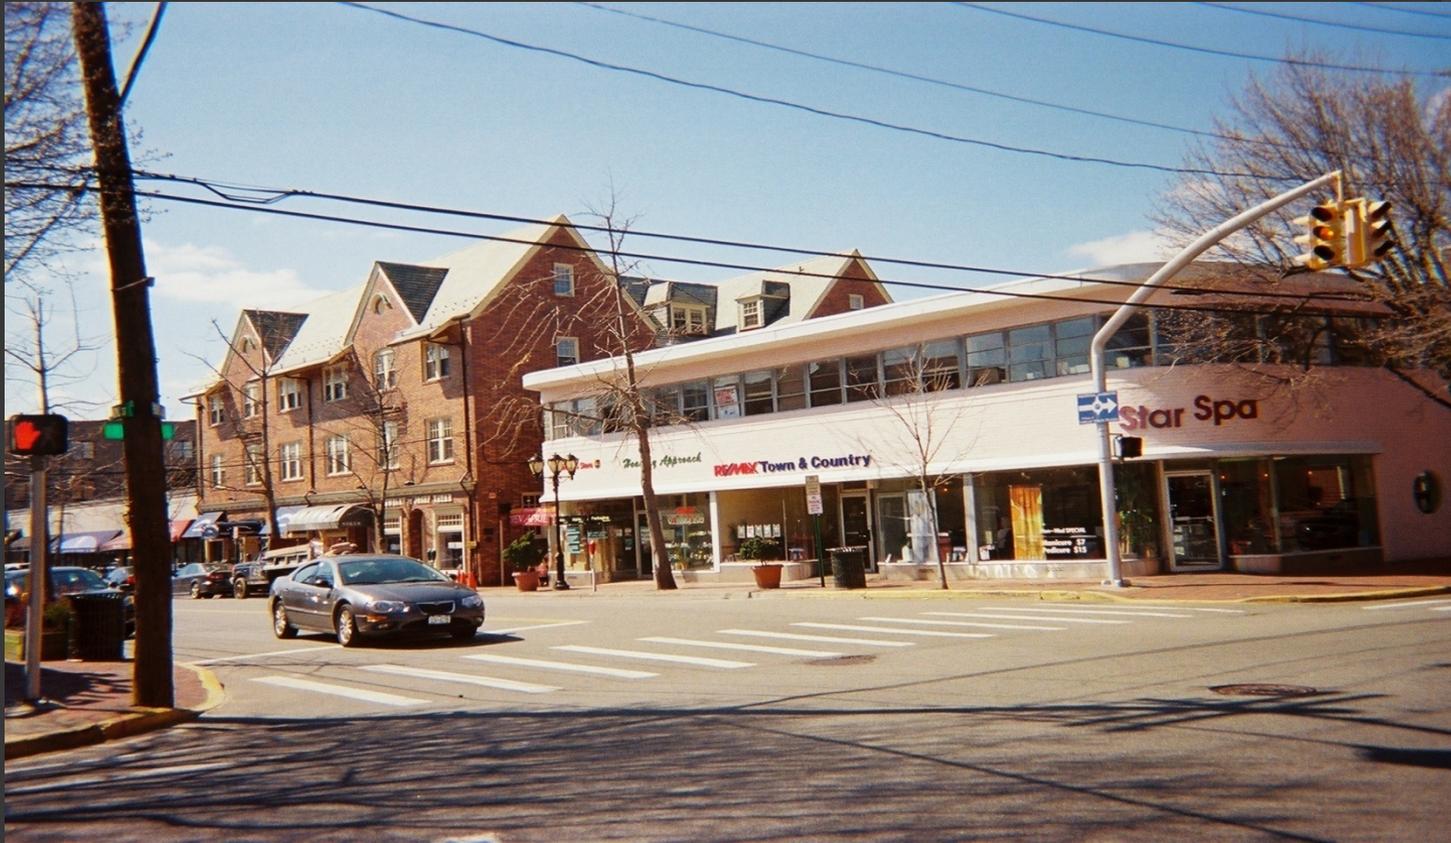
BOND STREET PHOTOS “BEFORE”

Existing Condition in Feb. 2008: Original wide suburban local street with one lane in each direction, and wide crossing of 44 feet for pedestrians.

Problem: Numerous conflicts with turning vehicles and pedestrians crossing at busy downtown intersection to restaurants (Great Neck Diner), train station (at other end of block) and retail stores on Bond Street.

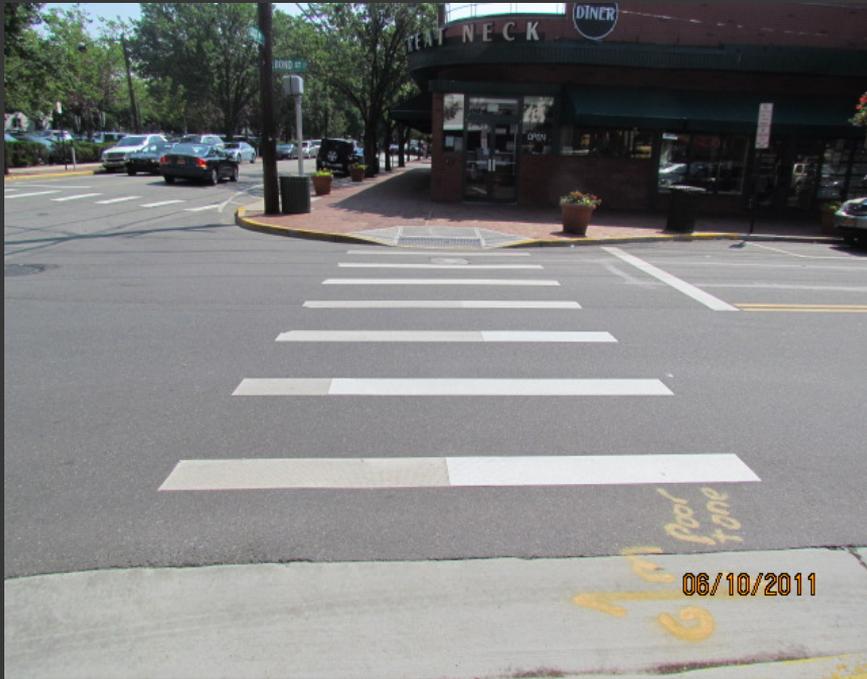
June 2010: Constructed Bulb-out at Grace Avenue looking east toward Great Neck Diner.

Benefit: Crossing distance of 44 feet was shortened 14 feet to a 30 feet crossing, making it safer, and easier for pedestrians, especially for those who are slower moving and physically challenged

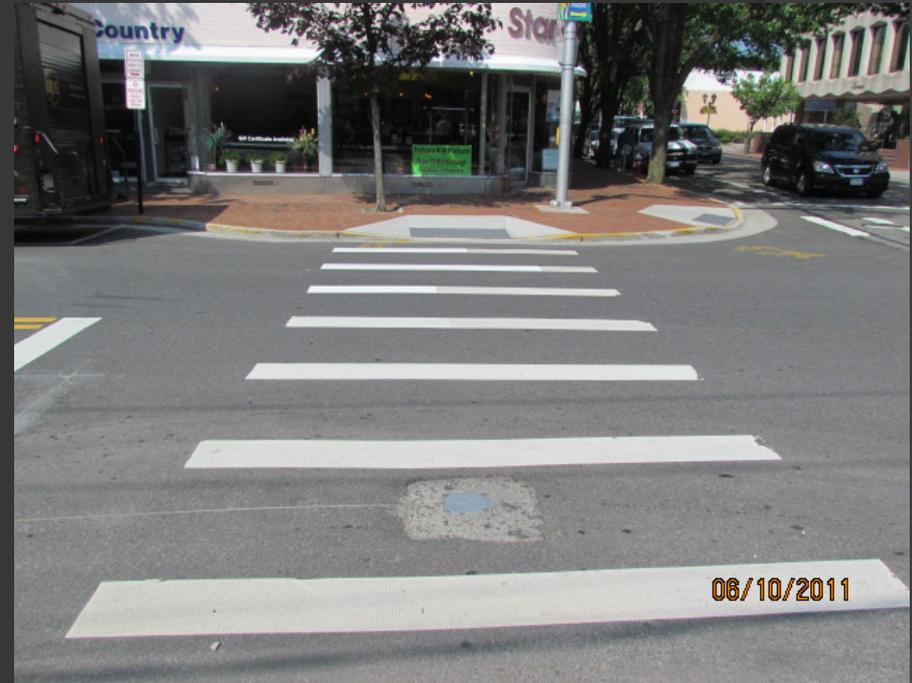
June 2010: Constructed Bulb-out at Grace Avenue looking west toward Star Spa

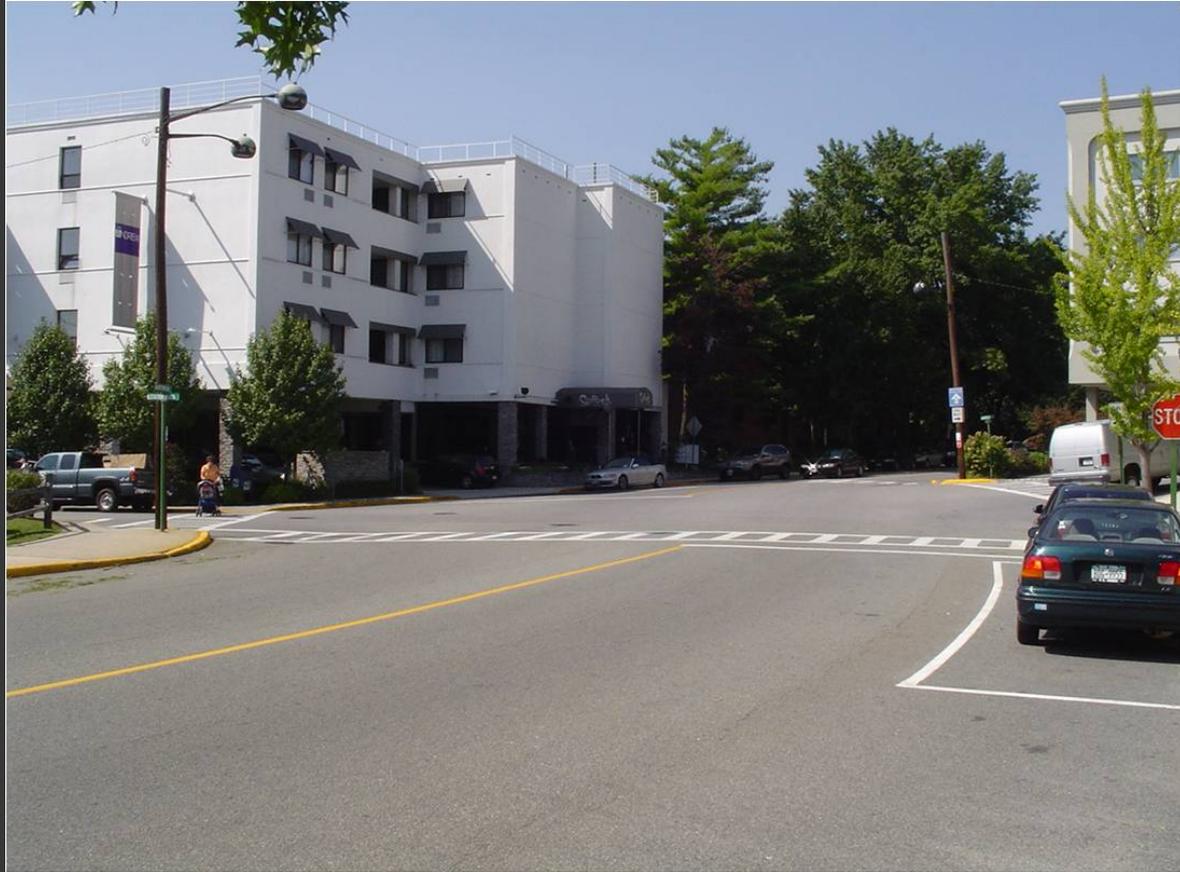
BARSTOW ROAD/LINDEN PL. PHOTOS - “BEFORE”

Existing Condition in July 2009: Original suburban local street with one lane in each direction, wide crossing for pedestrians and skewed intersection with Linden Place.

Problem: Numerous conflicts with turning vehicles and pedestrians crossing at busy downtown intersection to Andrew Hotel & Colbeh Restaurant, NY Sports Club and train station (to the right) and park (in background on Grace Avenue).

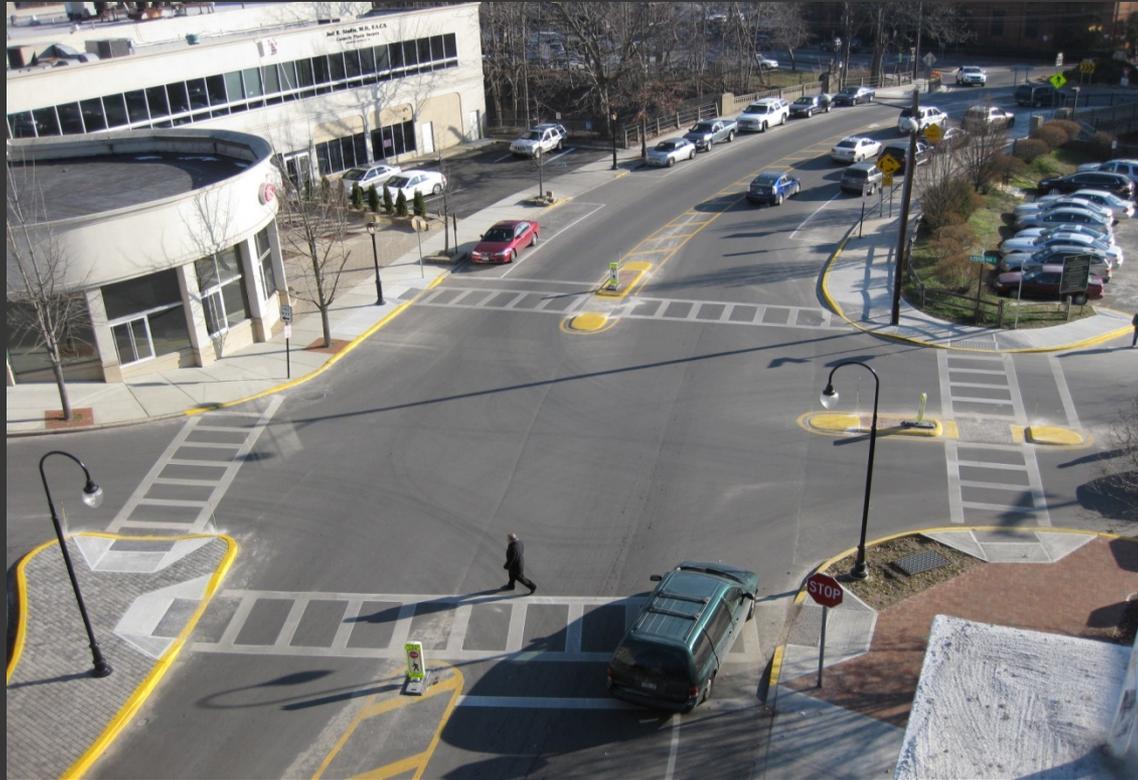
BARSTOW ROAD/LINDEN PL. PHOTOS - “AFTER”

Completed in September 2010: Normalized intersection with shorter pedestrian crossings, pedestrian refuges at all approaches, more highly visible crosswalks with ADA ramps, yield markings, and site lighting.

Benefit: Reduced conflicts with turning vehicles, lessened “rolling stops” and improved pedestrian safety by building more sidewalks, median island refuges, bulb-outs and tightening/normalizing intersection.

- ✓ NORMALIZED INTERSECTION TO REDUCE “SKEW” COMPLETED IN SUMMER, 2010
- ✓ BULB-OUTS OR EXTENSIONS ON CORNERS TO SLOW VEHICLES ENETRING INTERSECTION
- ✓ MEDIAN ISLANDS AT EVERY APPROACH TO SLOW VEHICLES AND PROVIDE PEDESTRIAN REFUGES
- ✓ SHORTENED PEDESTRIAN CROSSWALKS & INCREASED SIGNAGE , INSTALLED ADA CROSSWALK RAMPS
- ✓ REHABILITATED PAVEMENT WITH ASPHALT OVERLAY AND NEW PAVEMENT MARKINGS
- ✓ PROVIDED STREETSCLAPING / LANDSCAPING IMPROVEMENTS
- ✓ RETAINED ON-STREET PARALLEL PARKING

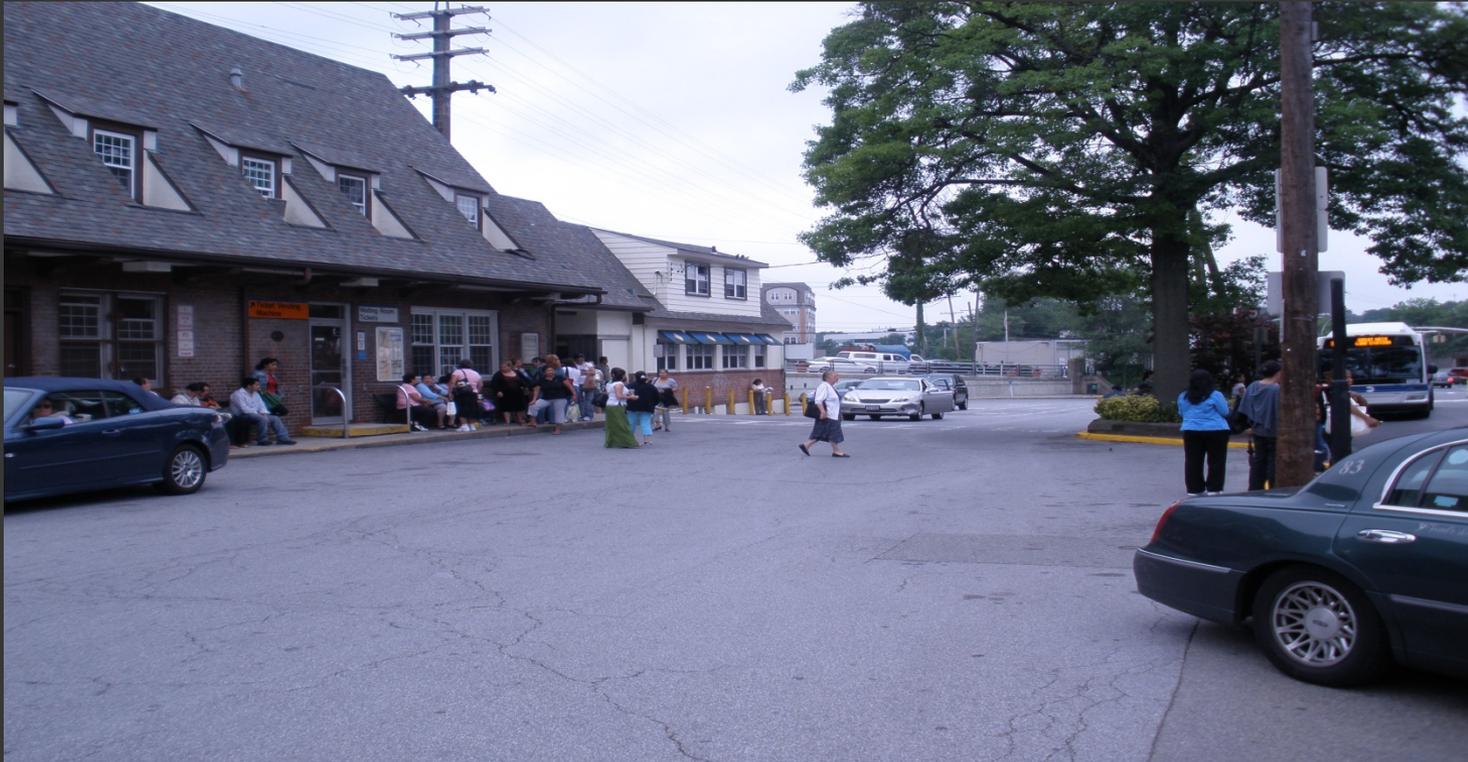
MIDDLE NECK ROAD PEDESTRIAN & BICYCLIST PHOTOS - “BEFORE”

Existing Condition in July 2009: Original LIRR Great Neck station access way with cars stopping in haphazard patterns and conflicting with pedestrians, wide undefined travel lanes and limited markings for pedestrians.

Problem: Busy train station with numerous fast approaching vehicles in “kiss and ride” drop off area, wide undefined travel lanes, and limited pavement markings to direct pedestrians arriving on foot, in buses, taxis and on bicycles.

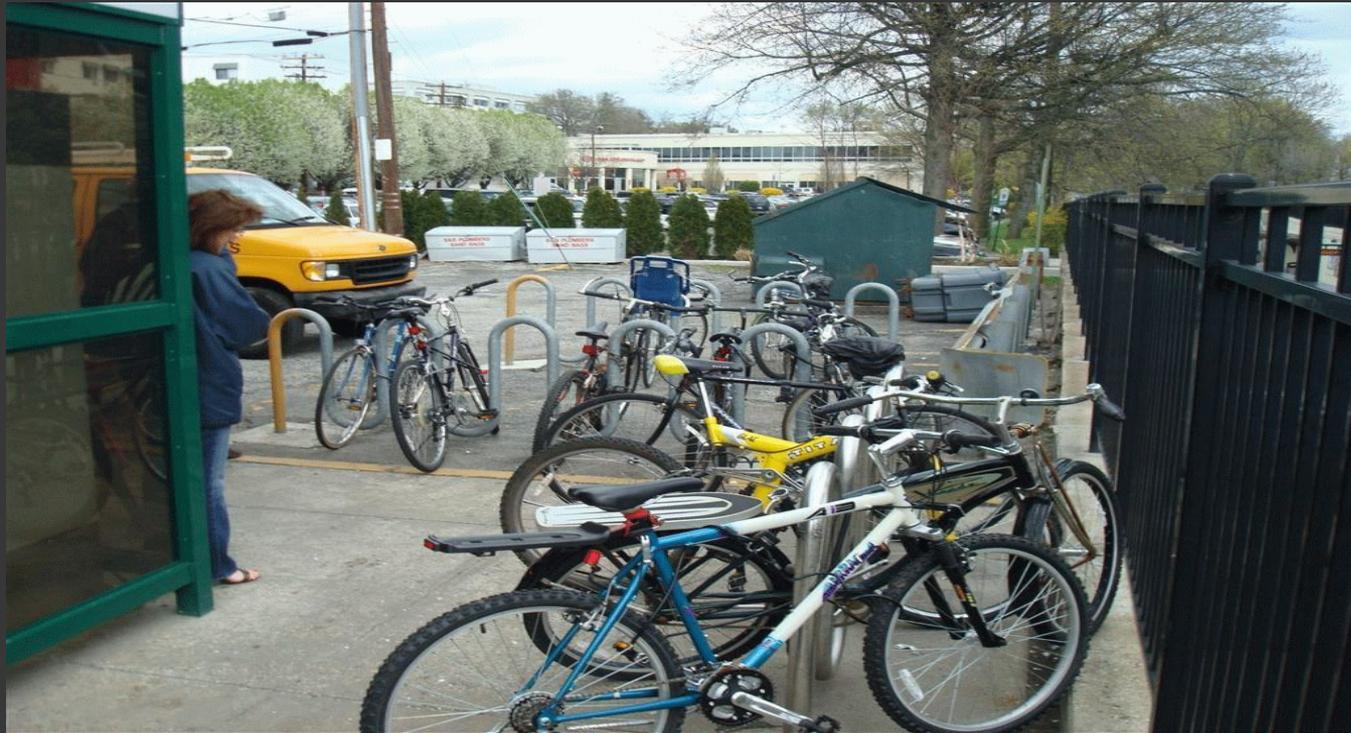
5th TEP GRANT – MIDDLE NECK ROAD PEDESTRIAN & BICYCLIST PHOTOS - “BEFORE”

Existing Condition in July 2009: Unprotected bicycle racks that are disorganized and scattered throughout LIRR Great Neck station making it difficult for commuters who choose to ride a bicycle to take mass transit.

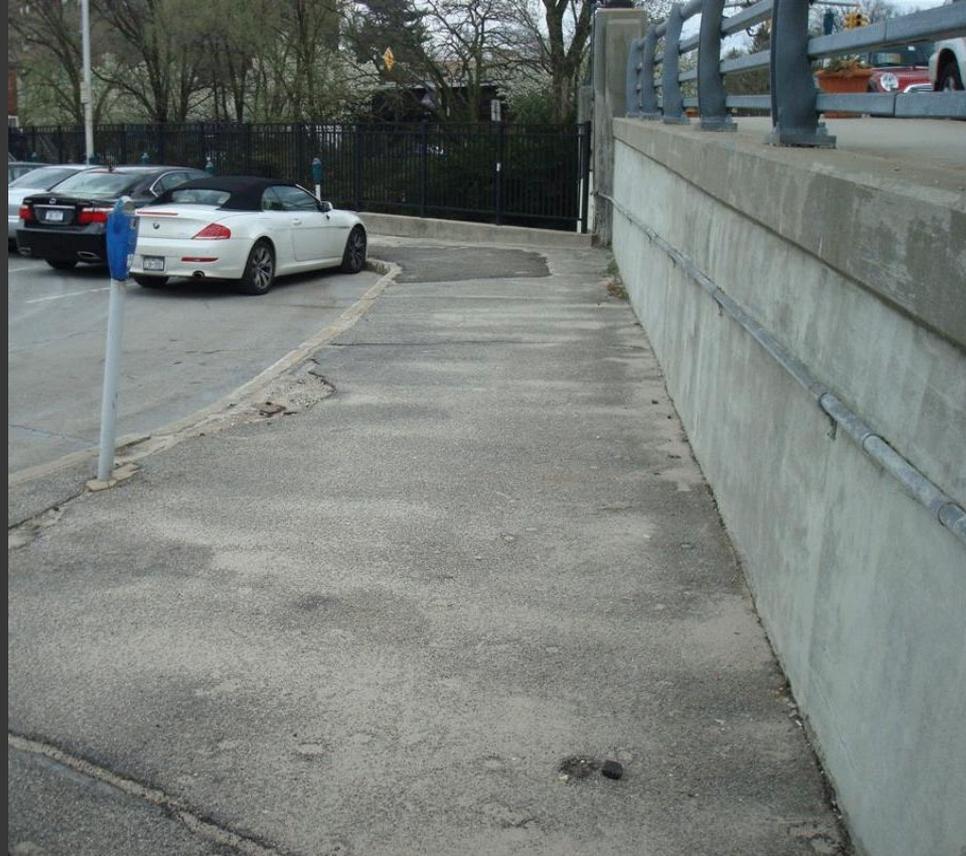
MIDDLE NECK ROAD PEDESTRIAN & BICYCLIST PHOTOS - “BEFORE”

Existing Condition in July 2009: Unused, unattractive asphalt sidewalk and plain, cement wall = urban design opportunity for enhancement with upgraded streetscape and public art.

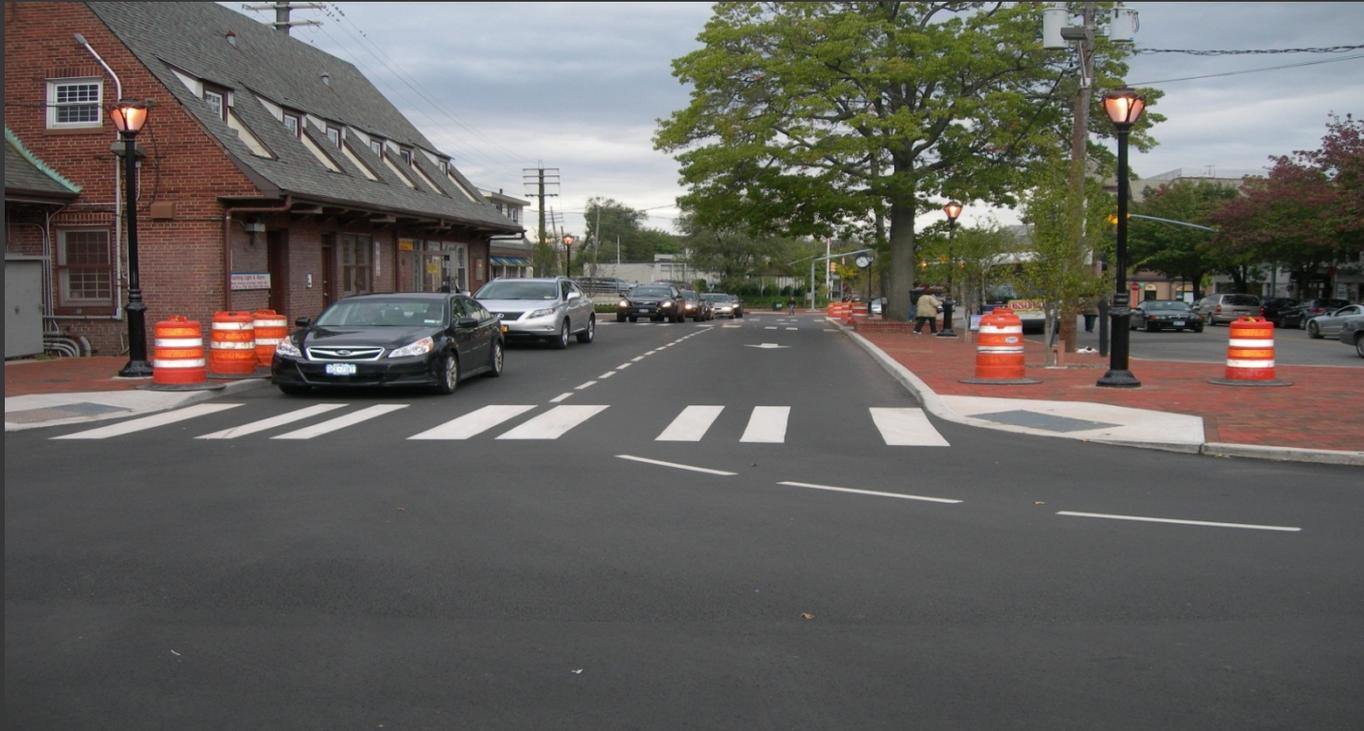
MIDDLE NECK ROAD PEDESTRIAN & BICYCLIST PHOTOS - “AFTER”

October 2011: Reconstructed access way with raised brick median separating “kiss and ride” commuters from bus patrons at outer curb with enhanced pavement markings for travel lanes, highly visible pedestrian crossings and direction arrows. Also note ADA curb ramps, new site lighting, new trees and tree pits, and brick sidewalks throughout.

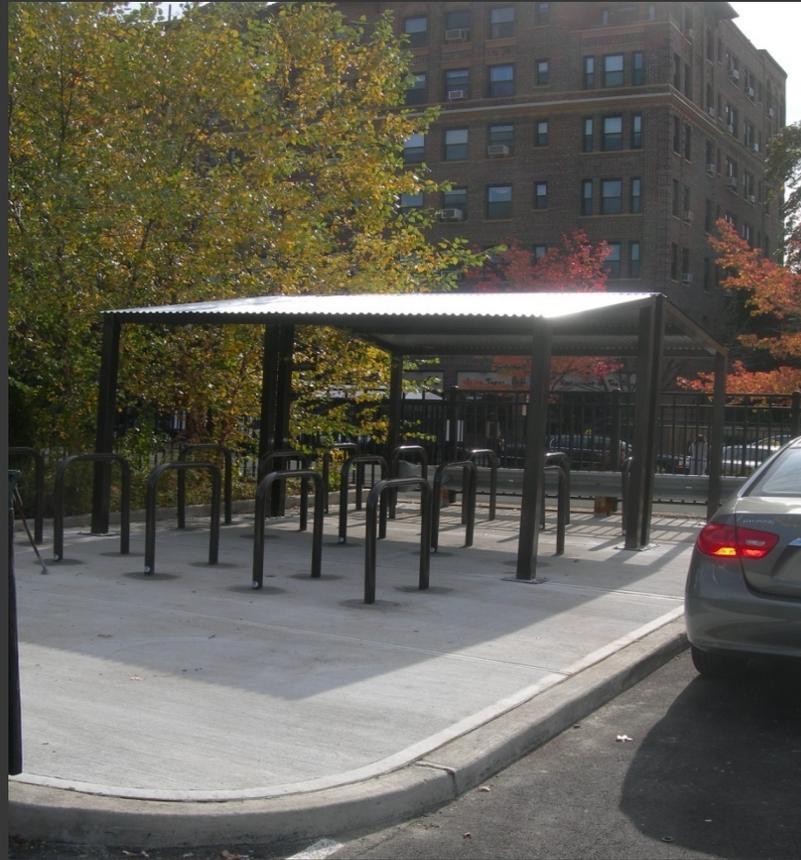
MIDDLE NECK ROAD PEDESTRIAN & BICYCLIST PHOTOS - “AFTER”

October 2011: Reconstructed new & improved bicycle parking facilities. Bicycle racks organized on a new, raised concrete pad with overhead canopy to protect bicycles.

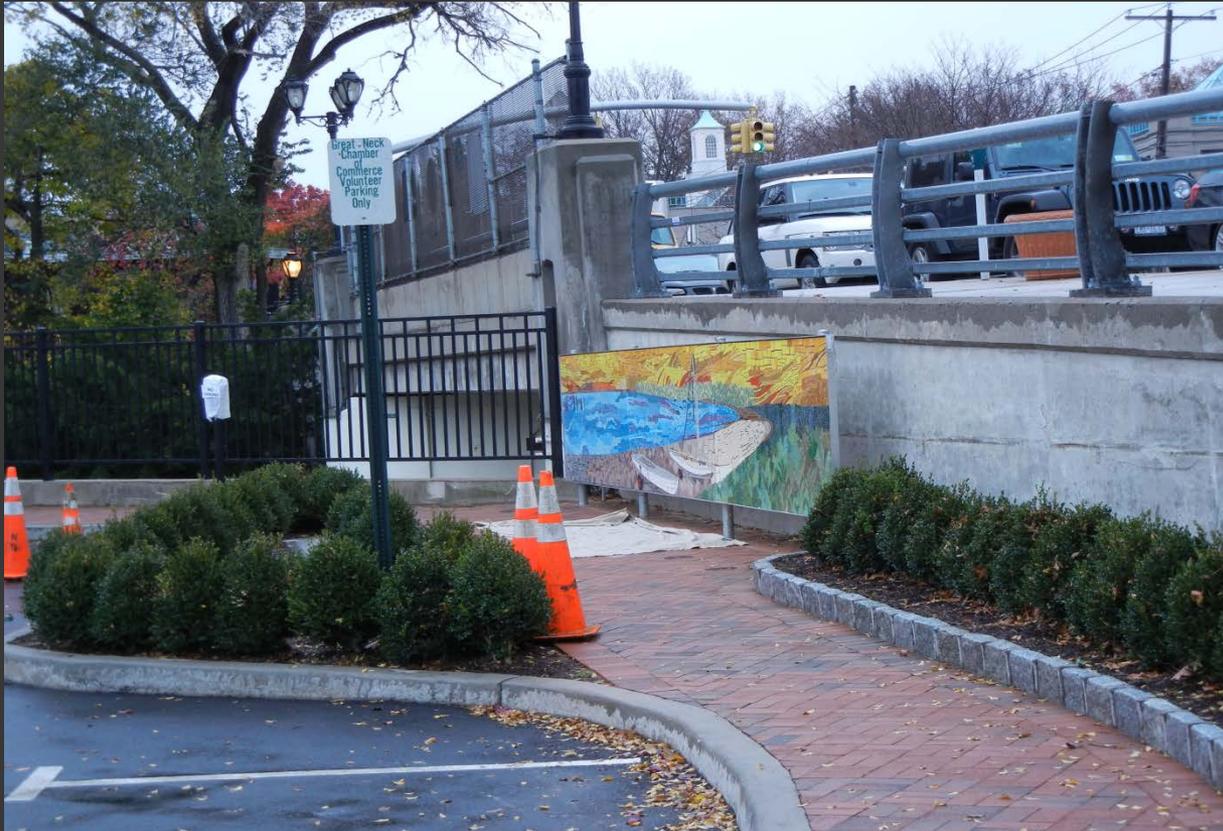
MIDDLE NECK ROAD PEDESTRIAN & BICYCLIST PHOTOS - “AFTER”

November 16, 2011: Installation of "Sunset on the Sound" mosaic tile public art mural with improved new brick sidewalks, benches and site landscaping to enhance the station area.
